**LETTER REPORT FOR
SITE AIR MONITORING AND SAMPLING ACTIVITIES
APRIL 6, APRIL 10, APRIL 11, APRIL 13,
APRIL 15, APRIL 16 and APRIL 17, 2006
AT THE
WILLIAMSBURG RECEIVING & STORAGE
AND CHERRY BLOSSOM LLC SITE
10190 MUNRO ROAD
WILLIAMSBURG, GRAND TRAVERSE COUNTY, MICHIGAN**

RE: Site Air Monitoring and Sampling Activities
April 6, April 10, April 11, April 13, April 15, April 16 and April 17, 2006
Williamsburg Receiving & Storage and Cherry Blossom LLC Site
Williamsburg, Grand Traverse County, Michigan
Contract No: 68-W-00-119
TDD: 0512-001
DCN: 574-2A-AGPV

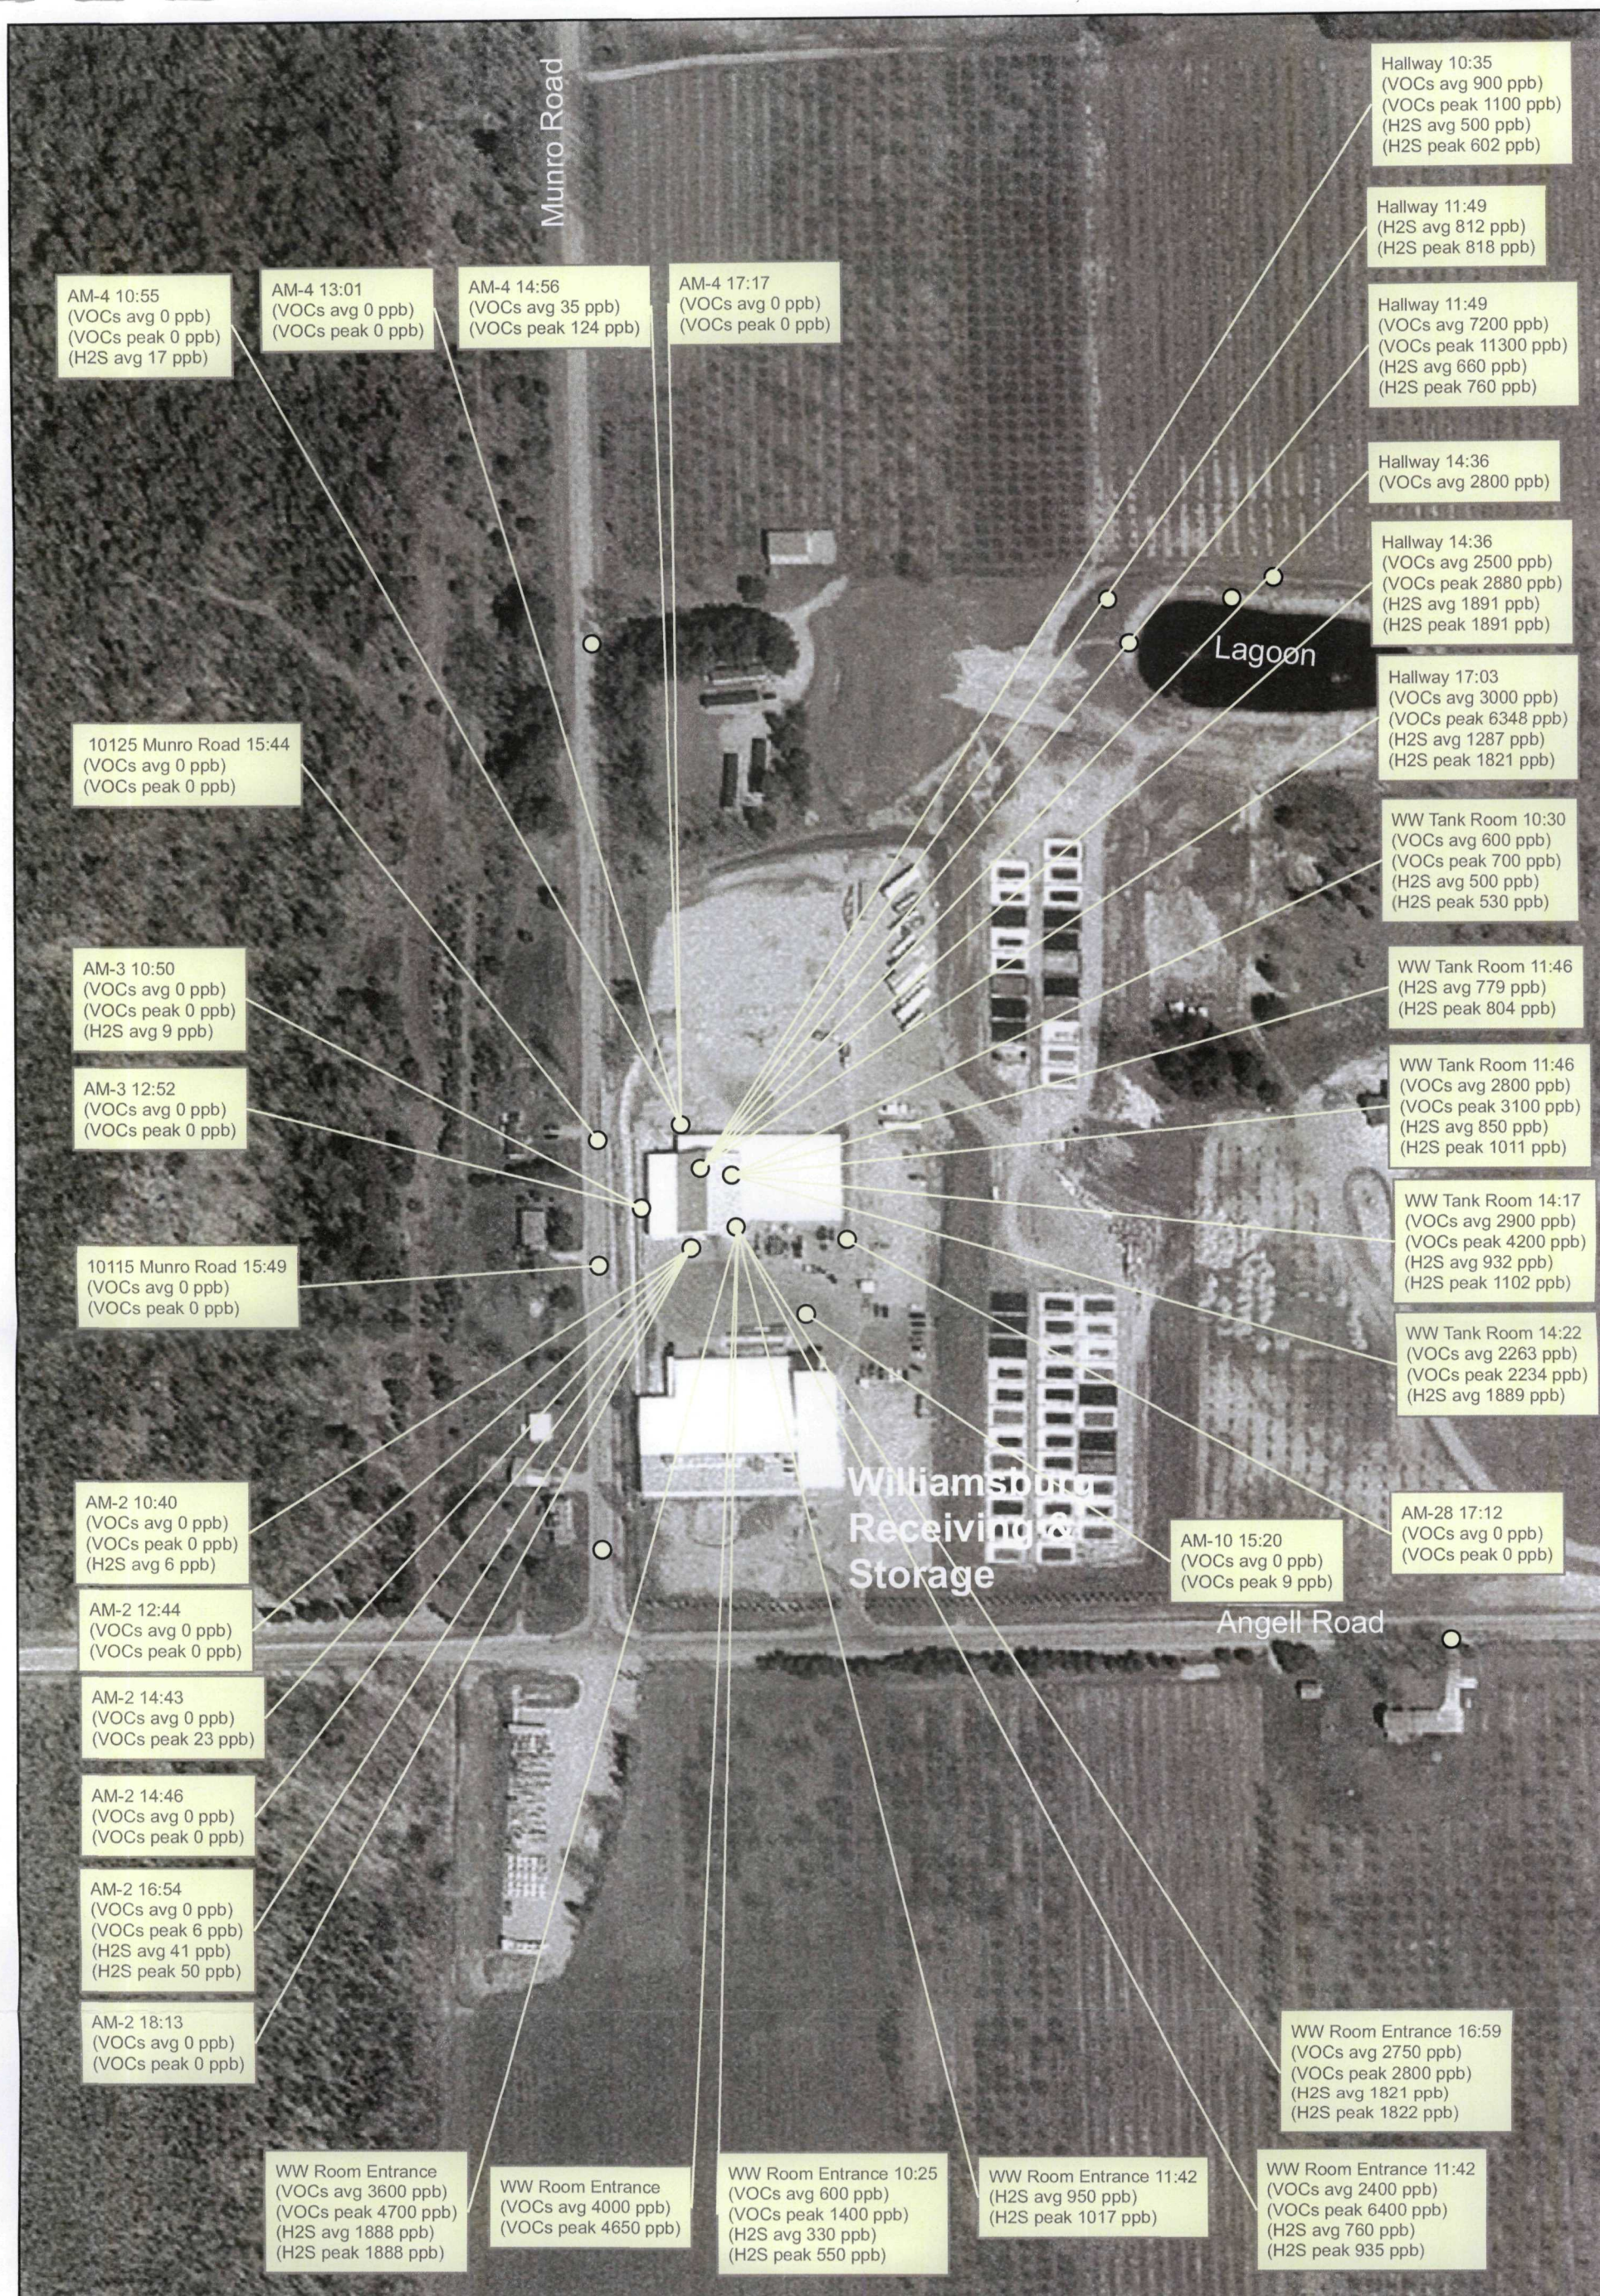
and hydrogen sulfide and VOC measurements from each monitoring location are illustrated on **Figures 2 and 3**. Monitoring location notes and monitoring results are summarized in **Table 2**.

A sweet, cherry-processing odor was present outside the WRS offices on April 10, 2006. A pungent, putrid odor mixed with a citrus odor was present within the wastewater tank building. The owner of the Site stated that the wastewater tanks vented into the perimeter hallway of the wastewater tank building, which is located within the maintenance building. This location exhibited a stronger citrus odor than putrid odor. The source of the citrus odor was the air freshener unit. The air freshener, ProSweet OC2533, is comprised mostly of essential oils and is located in a barrel inside a compressor that heats the oil to form a vapor. The vapor is pumped into the top of the tanks during filling activities. GRT personnel monitored the head space of the barrel with the air freshener and observed elevated VOC readings of 1,300,000 ppb and a hydrogen sulfide reading of 1,542 ppb. Due to the elevated VOC and hydrogen sulfide readings from the air freshener barrel, WRS was asked to turn the air freshener off so that measurements could be made without the presence of the air freshener in the air. The air freshener system was turned off at 1256 hours.

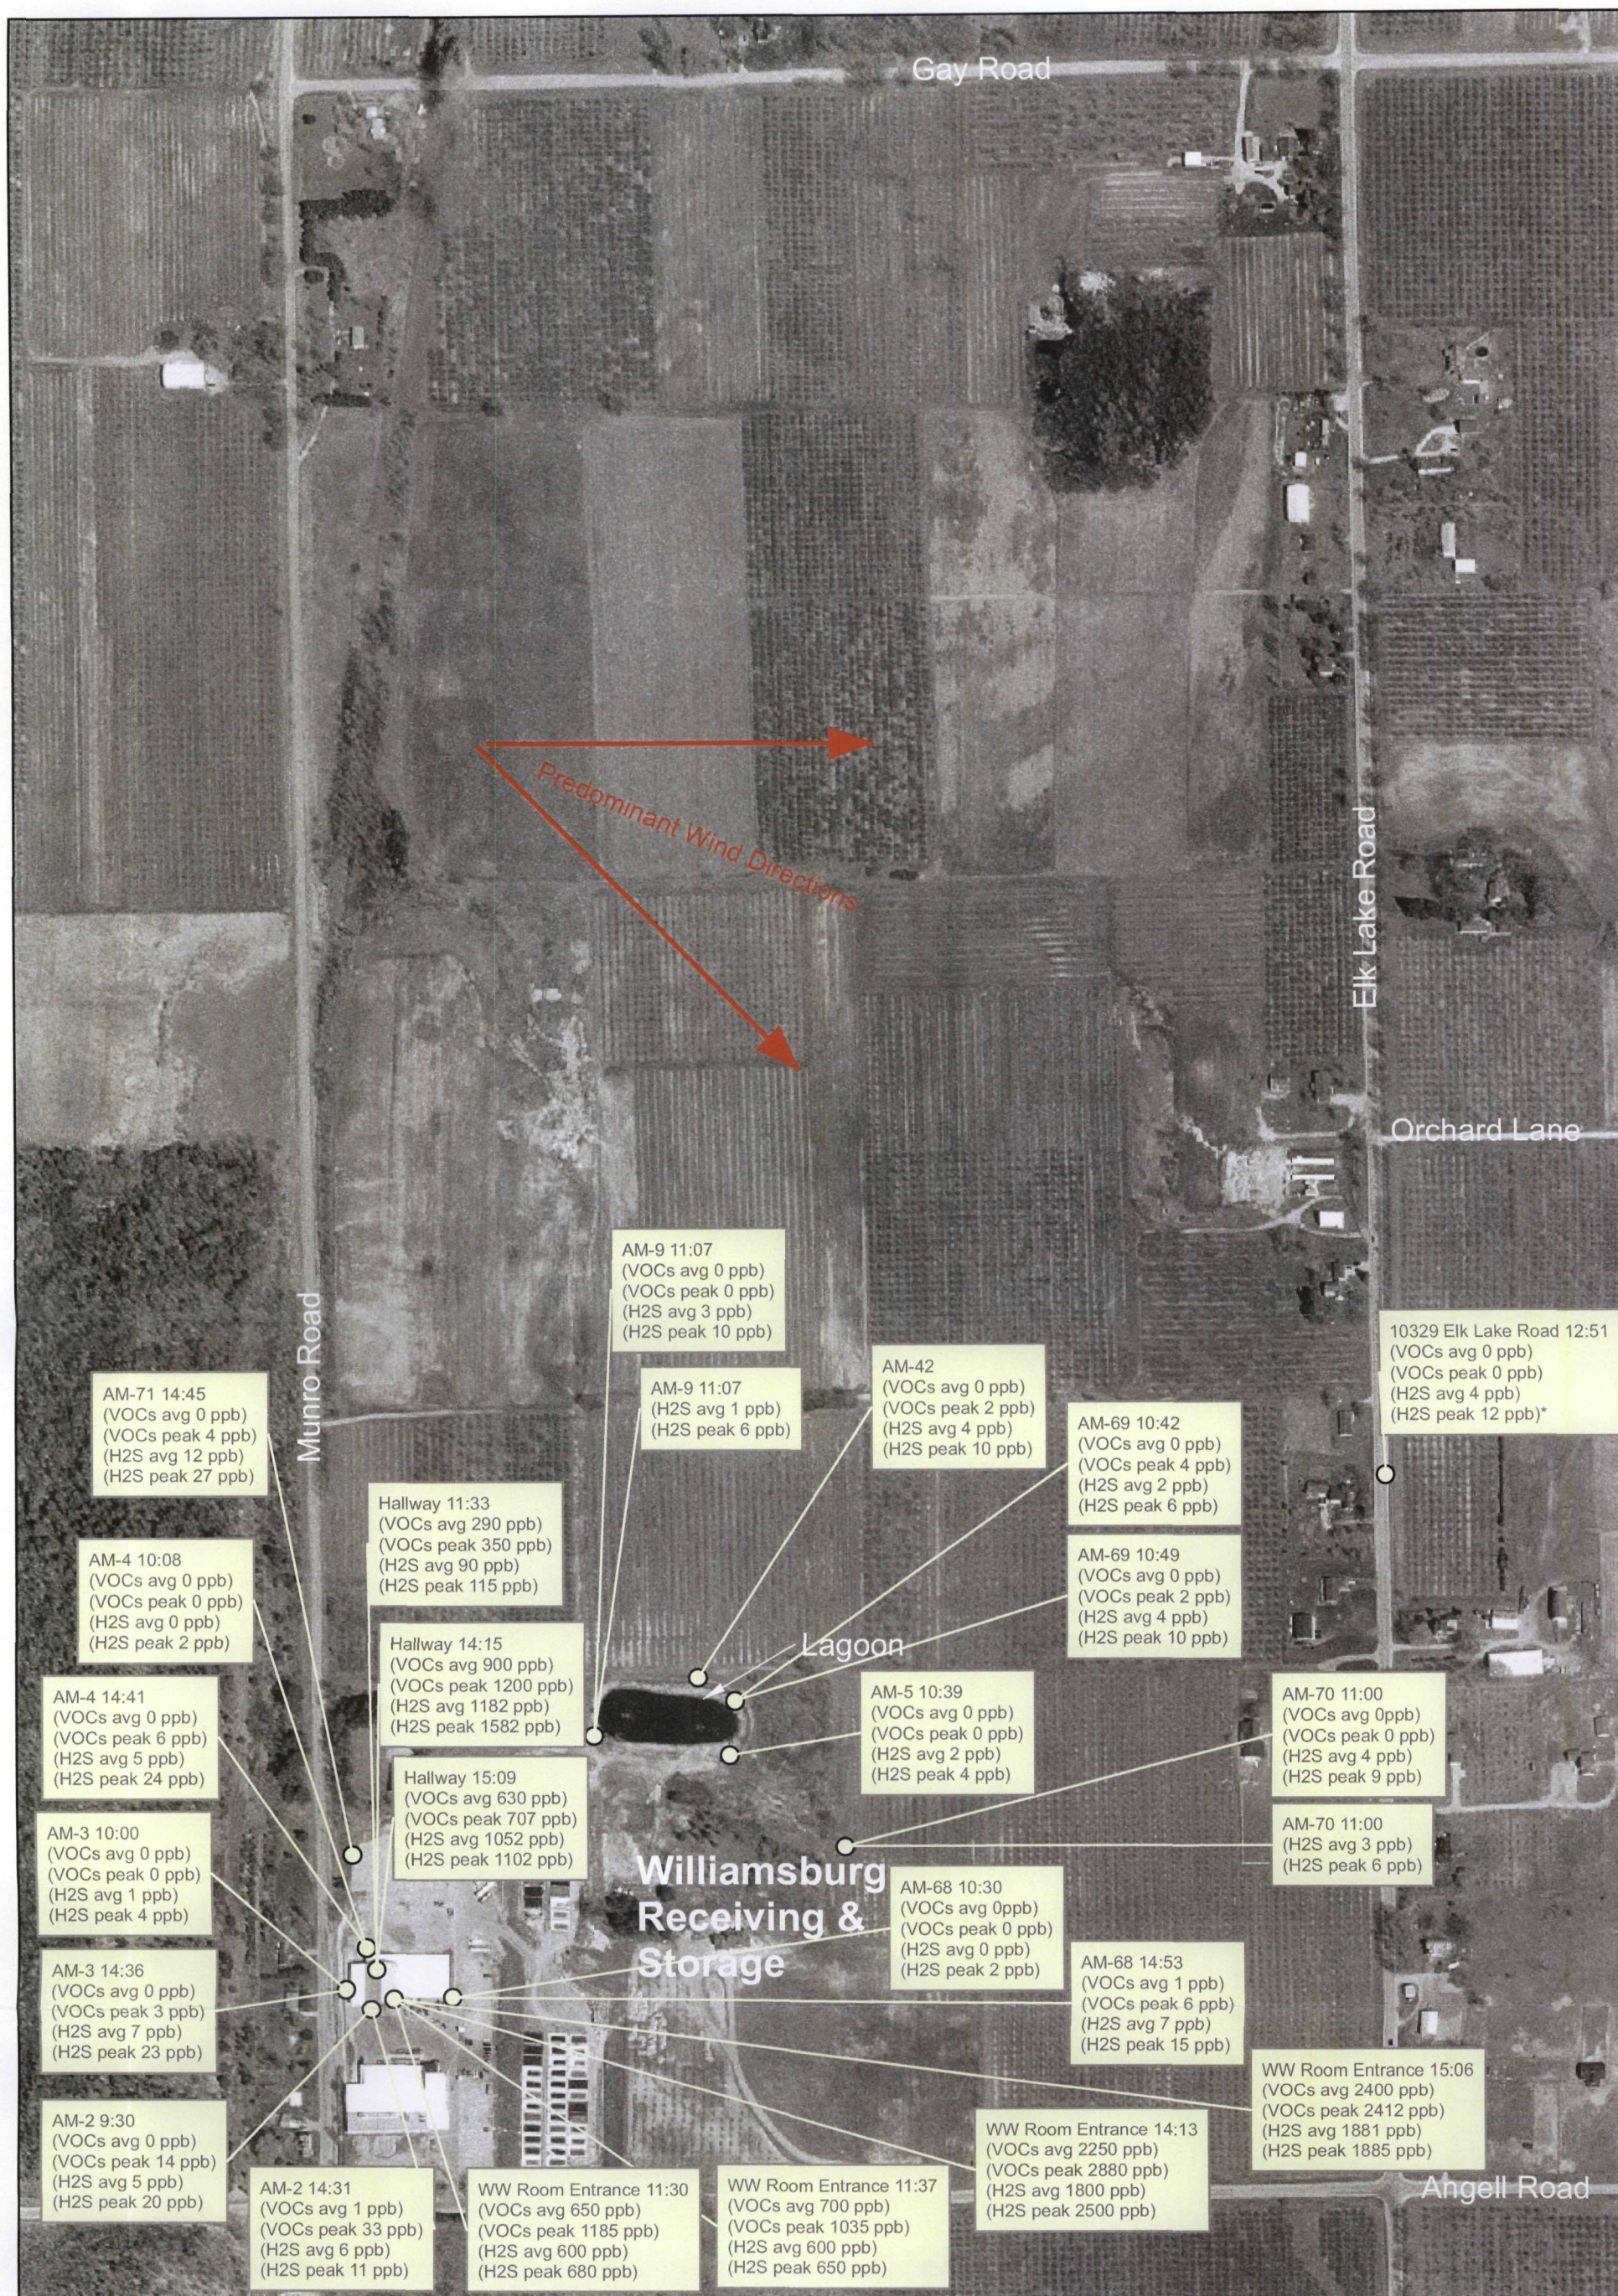
FIGURE 5

Pungent, putrid odors were present 20 feet south and east of the maintenance building while lagoon pumping and tanker loading activities were occurring. Odors were intermittent and were correlated with increased hydrogen sulfide and VOC readings. Winds were variable out of the west and north. No odors were detected by GRT personnel west and north of the maintenance building.

- Average hydrogen sulfide and VOC measurements along the lagoon perimeter were 3 ppb and 0 ppb, respectively;
- Average hydrogen sulfide and VOC measurements within the wastewater tank room prior to pumping from the lagoon were 600 ppb and 675 ppb, respectively;

- Air Monitoring Locations
- * Increase correlated with truck traffic.
(Samples obtained from breathing zone, unless noted otherwise.)
